WORKSHOP IEA SHC TASK 47, RETROFIT OF NON-RESIDENTIAL BUILDINGS:
AN INTERNATIONAL EXPERT VIEW ON EXEMPLARY PROJECTS

Kindergarten Vejtoften, Høje-Taastrup, Denmark

Kirsten Engelund Thomsen
Danish Building Research Institute, SBI
Aalborg University

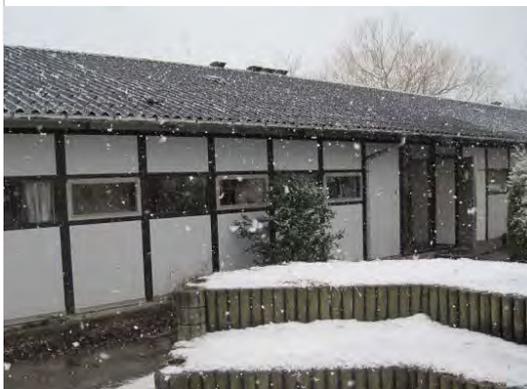
Façade facing playground - Before renovation

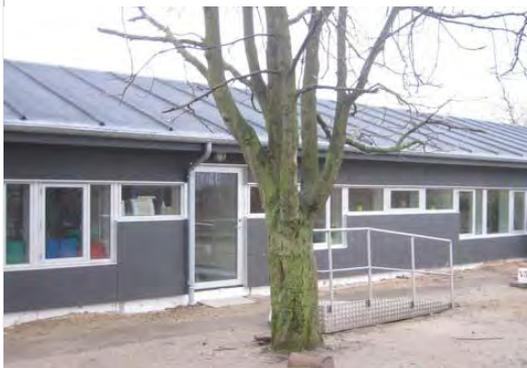
Façade facing garden - After renovation

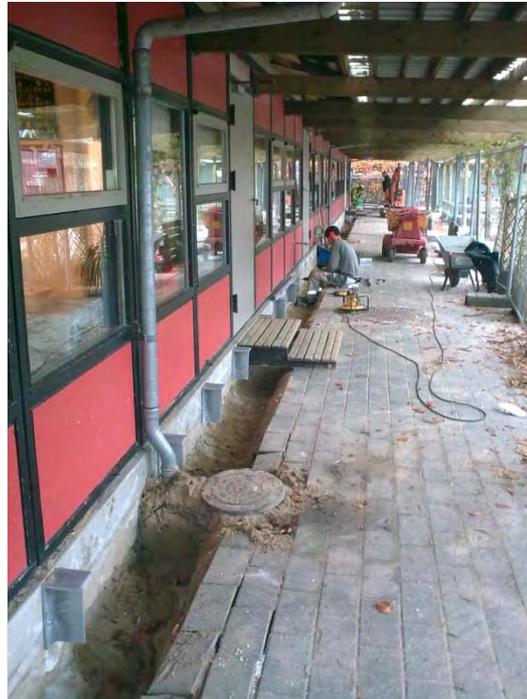
*Above: Façade before renovation
Below: Existing insulation and windows*

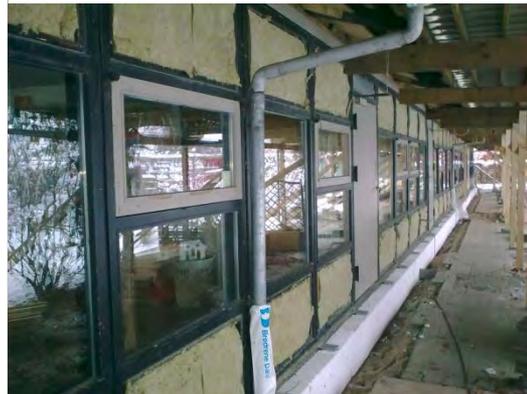
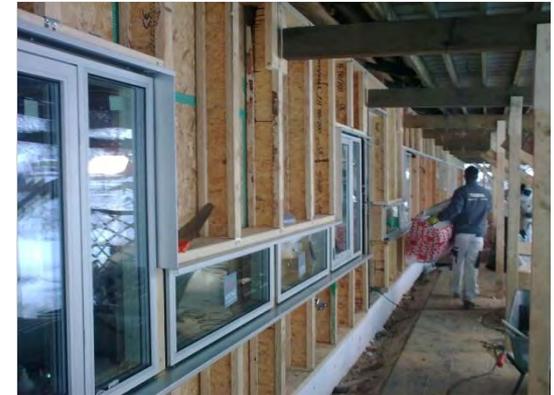
*Above: Old insulation has been removed and new windows have been installed
Below: New insulation has been added*

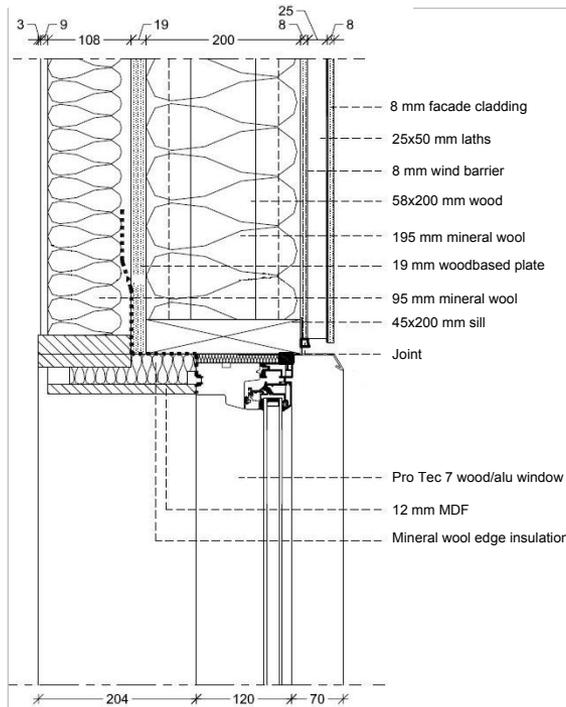
Cross section window/wall joint. The existing insulation of 95 mm have been replaced and a new layer of 195 mm insulation have been added to the exterior wall. The window has been moved out in the construction. The original thermal bridges in the wall and the thermal bridge at the joint are reduced significantly.

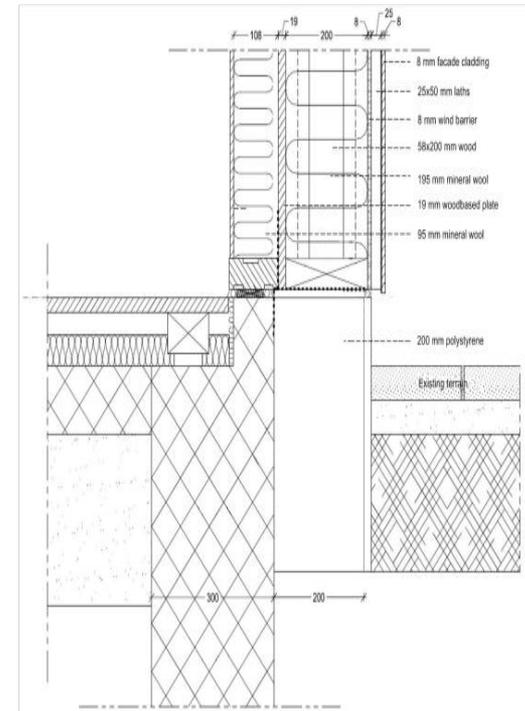
From the cross sections shown to the right, it is clear that the thermal bridges have been reduced significantly. The foundation was insulated with 200 mm polystyrene to a depth of 400 mm, which reduced the heat loss through the slab floor and foundation considerably.

Cross section floor slab/wall. 200 mm x 400 mm insulation has been added to the base of the building to reduce thermal bridge effects. In addition to reducing the heat loss this has also raised the temperature of the floor and thereby improved the indoor climate. Now the entire floor area is useable for the occupants.

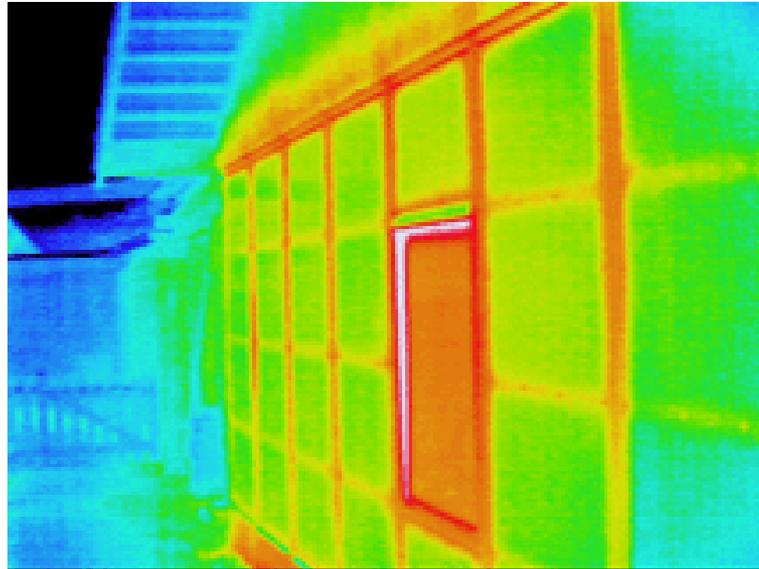
Left: Thermography before renovation. Notice how the beams in the existing wall and the frame of the window create large thermal bridges. Also the window itself is showing a significant heat loss.

Right: Thermography after renovation. The thermal bridges have disappeared almost completely, and it is clear that the two layers of insulation are efficient in reducing the heat transmission through the thermal envelope. The heat loss through the window is clearly also reduced.

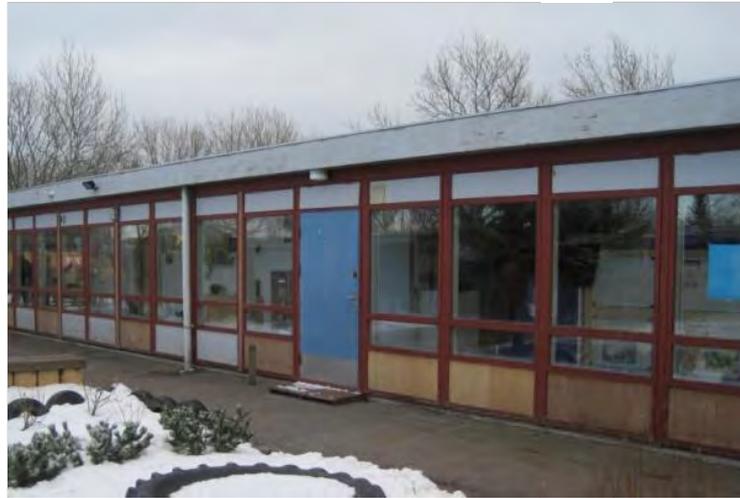
Left: Facade facing the playground before renovation. The painted facade required regular maintenance.

Right: Facade facing the playground after renovation. The new facade requires little/no maintenance.
