### PROJECT SUMMARY

## Kampen School, Norway

### IEA SHC Task 47

Renovation of Non-Residential Buildings towards Sustainable Standards

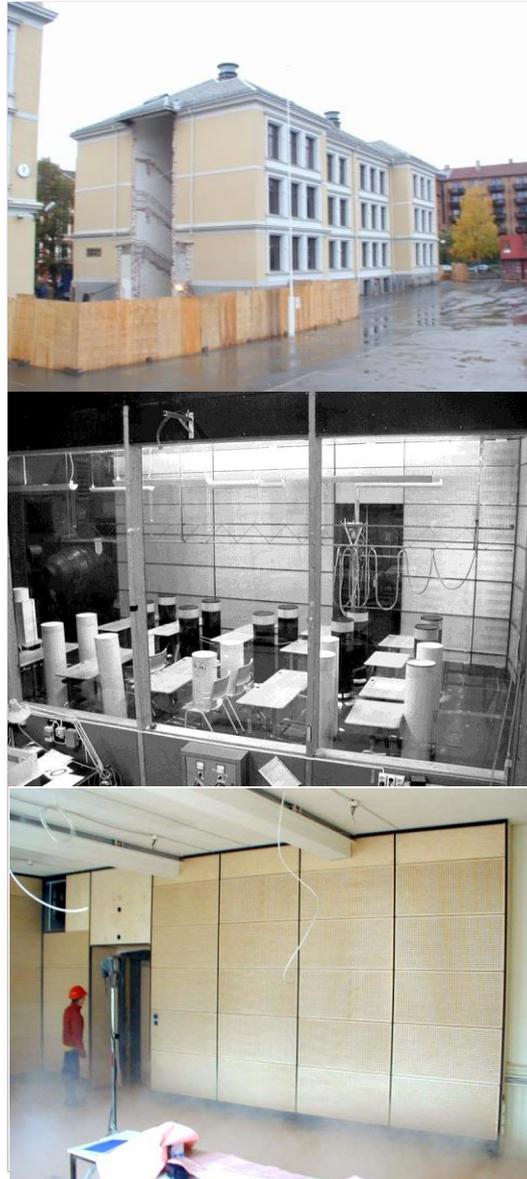
Pictures (from the top):

1. Ongoing construction work
2. Laboratory smoke test of supply air from a perforated wall
3. At site: Smoke test of supply air wall

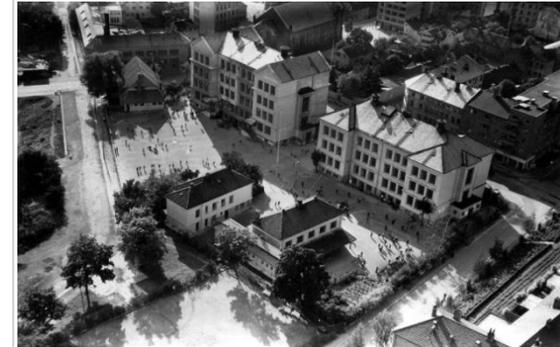
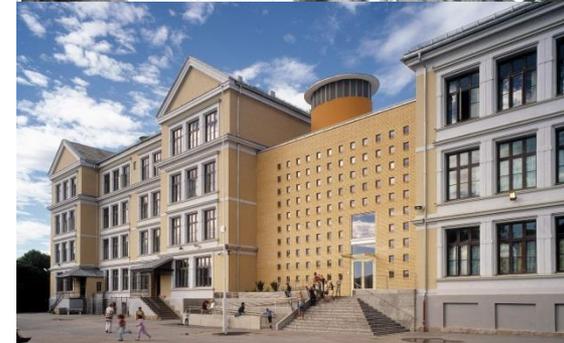
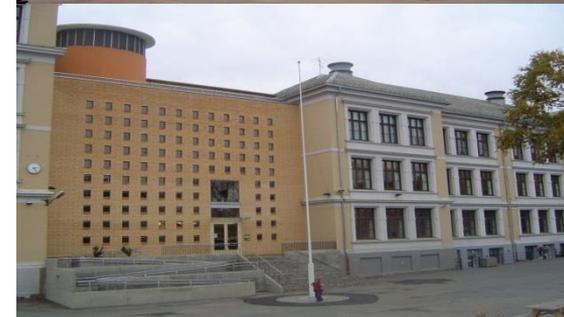
### Pictures (from the top):

- The Kampen School area
- New building intervening the existing buildings

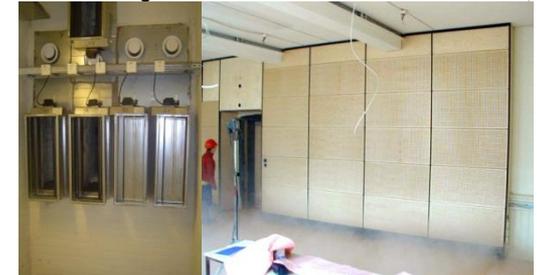
Based on the original building's integrated ventilation solution from 1888. Fan assisted natural ventilation, or hybrid ventilation. Because of traffic pollution, there is a new air intake on the top of the new intervening building. The air passes through a filter and a run-around heat recovery battery with low pressure drop, then passes via a concrete duct, under the building, finally through vertical shafts up to each classroom. The rooms are ventilated with displacement ventilation through an integrated wall that will ensure no conflict between ventilation function, draft and the use of the rooms. The inlet for supply air is placed behind the new wall. A shelf under the air inlet is designed to spread the air equally along the long side of the classroom. The air is then distributed to the room through a perforated zone in the lowest meter of the wall.

Supply air temperature will increase about 2°C from the inlet behind the integrated wall to the air inlet in the room. This means that the new integrated wall also will serve as a cooling panel, making it possible to add some extra cooling to the ventilation air.
