PROJECT SUMMARY Construction year: 1953 Energy renovation: 2009 No past energy renovations

Osram Culture Centre – Copenhagen, Denmark

Valhalsgade 4, 2200 Copenhagen N

IEA – SHC Task 47 Renovation of Non-Residential Buildings towards Sustainable Standards

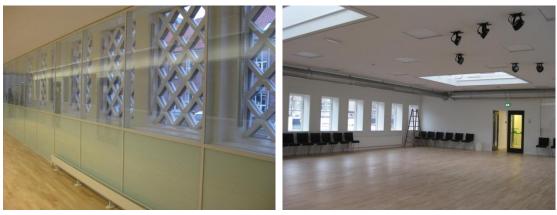
Daylighting and natural ventilation via roof windows.

In the renovated building, mechanical ventilation with heat recovery was installed and this was supplemented by natural ventilation via the roof windows. The natural ventilation is controlled by electric motors based on the indoor climate.

The indoor air quality has improved significantly with the introduction of a combined mechanical and natural ventilation system. The mechanical system has heat recovery and ventilates the building during winter. When indoor temperatures or CO_2 levels in the building get too high, the automatic natural ventilation is initiated (opening of roof windows).

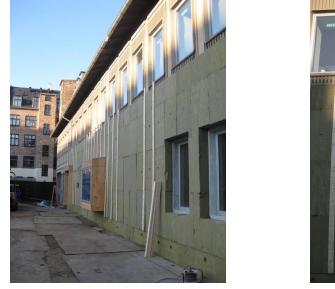
The ground floor of the back façade was insulated from the outside.

380 mm of insulation was added on the inside. The lower part of the back façade was insulated on the outside.

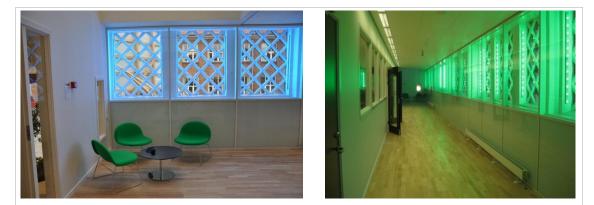
Decorative multi-colored LED-lights were placed in the window sills.

Also, decorative LED lighting was added to the window sills in the original façade windows of the building, making it possible to set the scene for any arrangement in the building.

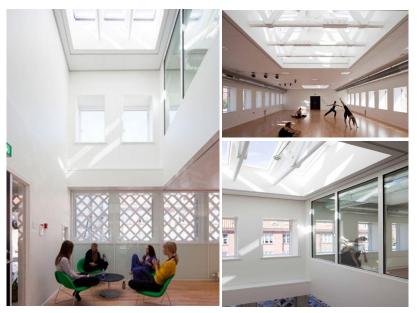
The roof windows have a significant and positive influence on the daylighting level in the building.

The indoor climate of the building was improved significantly by the renovation process. Daylighting levels in the building were raised by introducing roof windows, raised daylight levels on the first floor and on the ground floor (see pictures).

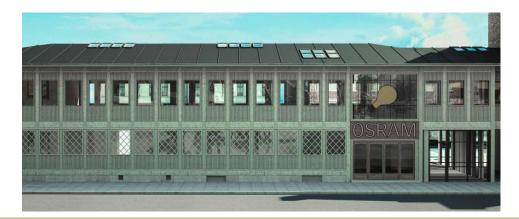
Energy saving measure	Investment total [€]	Investment energy [€]	Savings [€/yr]	Payback time [yr]	CO ₂ reduction [kg CO ₂ /yr]
Façade insulation	120,267	86,667	3,600	24.1	7,740
Windows/doors	70,933	20,000	4,200	4.8	9,030
Inside glazing	48,000	48,000	1,200	40.0	2,580
Heating system	60,533	13,333	900	14.8	1,935
Lighting system	220,654	26,667	1,968	13.6	5,292
Controls	35,600	6,667	709	9.4	1,584
Solar panels	8,000	6,667	360	18.5	774
Total/mean	563,988	212,000	12,937	17.9	28,935
