# Rockwool International Office Building "Center 2" Hovedgaden 584, 2640 Hedehusene, Denmark

# IEA SHC Task 47 Renovation of Non-Residential Buildings towards Sustainable Standards

PROJECT SUMMARY Construction year: 1979 Energy renovation: 2013

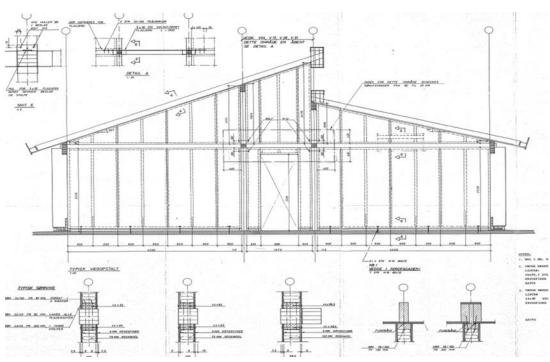
Facade before and after retrofitting

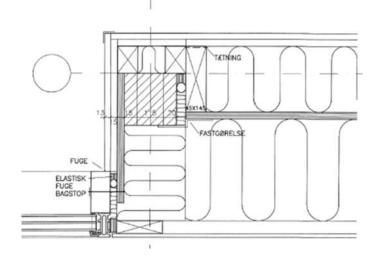
New facade, U-value 0.08 W/m<sup>2</sup>K

Wall construction U-value: 0.08 W/m<sup>2</sup>K Gypsum board Vermacel board 145 mm ROCKWOOL, A-Flexi Batts Plywood 250 mm ROCKWOOL, FLEXSYSTEM batts Rockpanel board

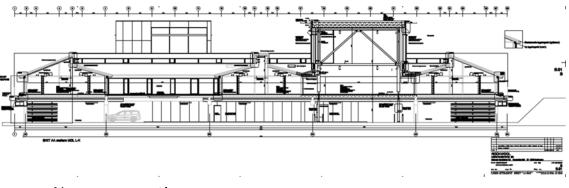
New cross section

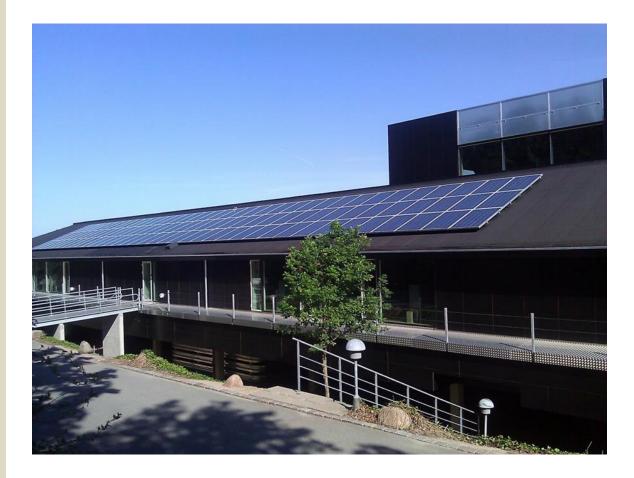
86 m<sup>2</sup> heat collector mainly for hot water (production 3 kWh/m<sup>2</sup> heated floor area per year)

170 m<sup>2</sup> PV (production 7 kWh/m<sup>2</sup> heated floor area per year)

A solar collector for hot water production was installed.

RENEWABLE ENERGY SYSTEMS A 170 m<sup>2</sup> PV system was installed.

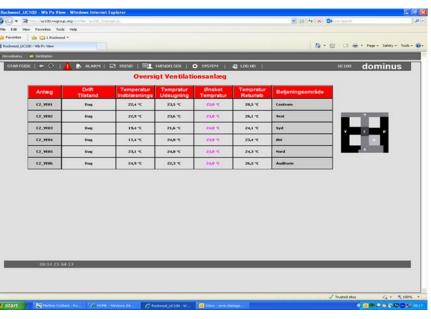
The new CTS control system.
