WORKSHOP IEA SHC TASK 47, RETROFIT OF NON-RESIDENTIAL BUILDINGS:
AN INTERNATIONAL EXPERT VIEW ON EXEMPLARY PROJECTS

Kindergarten Vejtoften, Høje-Taastrup, Denmark

Kirsten Engelund Thomsen
Danish Building Research Institute, SBI
Aalborg University

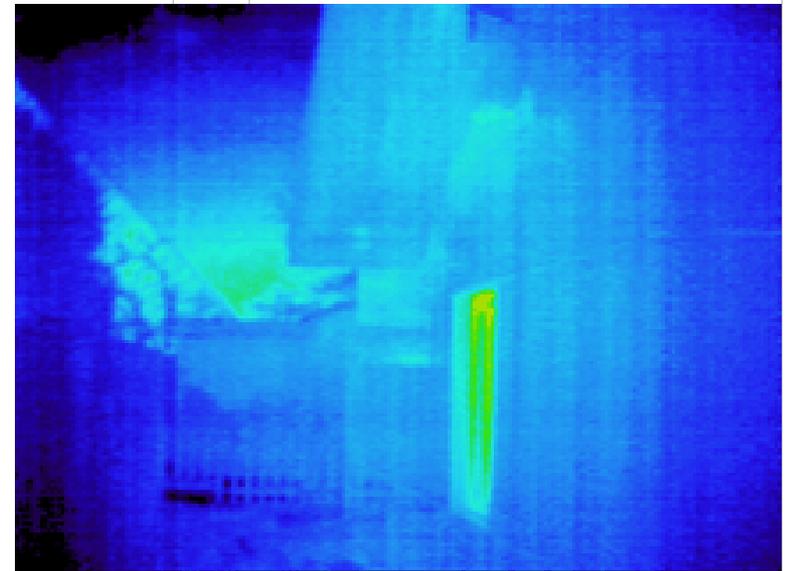
Left: Thermography before renovation. Notice how the beams in the existing wall and the frame of the window create large thermal bridges. Also the window itself is showing a significant heat loss.

Right: Thermography after renovation. The thermal bridges have disappeared almost completely, and it is clear that the two layers of insulation are efficient in reducing the heat transmission through the thermal envelope. The heat loss through the window is clearly also reduced.

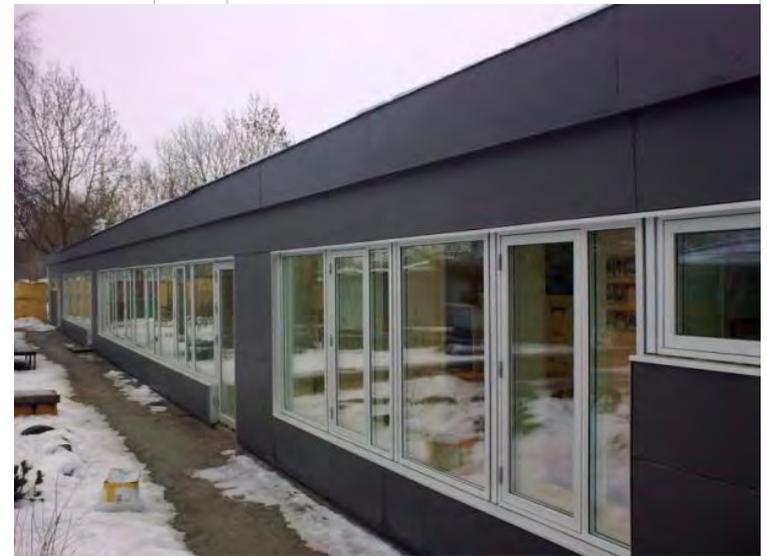
Left: Facade facing the playground before renovation. The painted facade required regular maintenance.

Right: Facade facing the playground after renovation. The new facade requires little/no maintenance.
